## REDUCING THE SHORTAGE OF GREEN TYRE IN TYRE MANUFACTURING PROCESS

DEEPU P. NAIR<sup>1</sup>, DEEPAK ELDHO BABU<sup>2</sup>, JACOB KURIAKOSE<sup>3</sup> & VINOD YELDHO BABY<sup>4</sup>

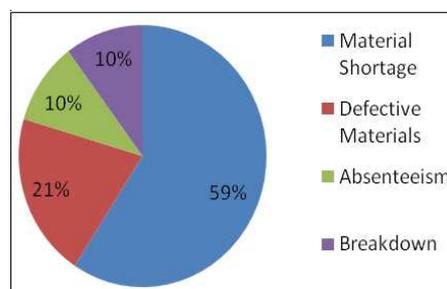
**Figure 1: Pie Chart Showing Causes for Production Loss**

From the Figure 1 it is clear that the material shortage (59%) accounts for the most of production loss of green tyre to the company. There are different types of materials which are used in green tyre for assembling in tyre building

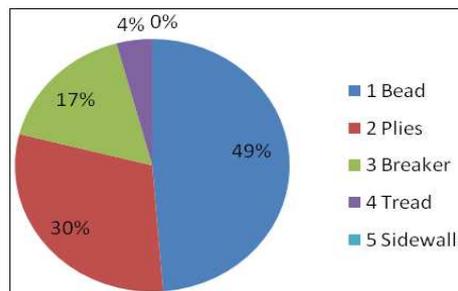
machines are bead, plies, breakers, tread, sidewalls. The tonnage losses of each of the material shortage are given in Table 2. From the Figure 2 it is clear that the bead shortage accounts (49%) of the production loss to the company.

**Figure 2: Pie Chart Showing Material Shortage for Production Loss**

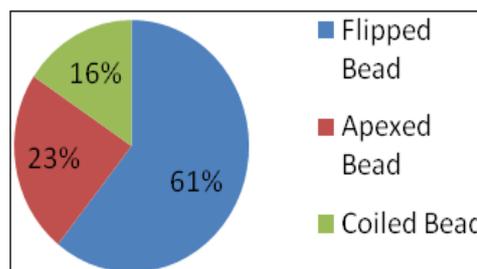
From the Figure 3 it is very clear that flipped bead causes for the major production loss. It accounts 60% of losses compared to coiling and apexing. So that root cause analysis was conducted to identify root cause of the flipped bead.

**Figure 3: Pie Chart Showing Material Shortage in Bead Preparation Unit**

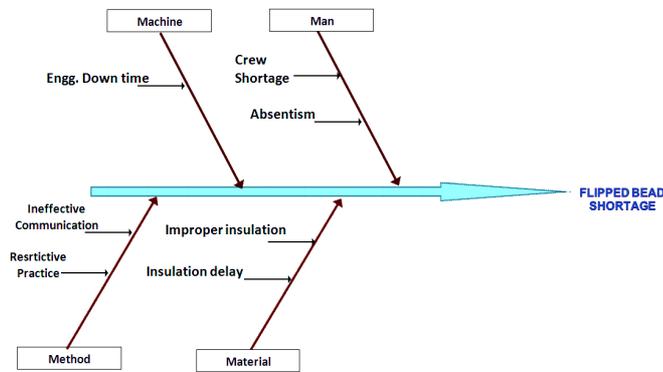
**Figure 4: Initial Cause and Effect Diagram of Flipped Bead Shortage**

Figure 4 shows the initial cause and effect diagram of flipped bead shortage. The cause of flipped bead shortage may be due to improper insulation, insulation delay, crew shortage and engineering downtime.

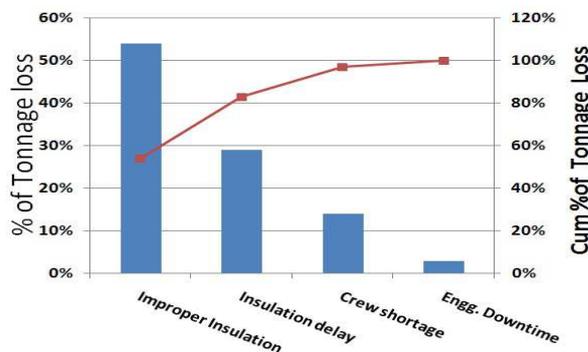
A Pareto chart Figure 5 was constructed as per the percentage of loss in hours of each causes of flipped bead shortage. From the graph it is clear that the improper insulation is the major causes of flipped bead shortage.

**Figure 5: Pareto Chart of Flipped Bead Shortage**

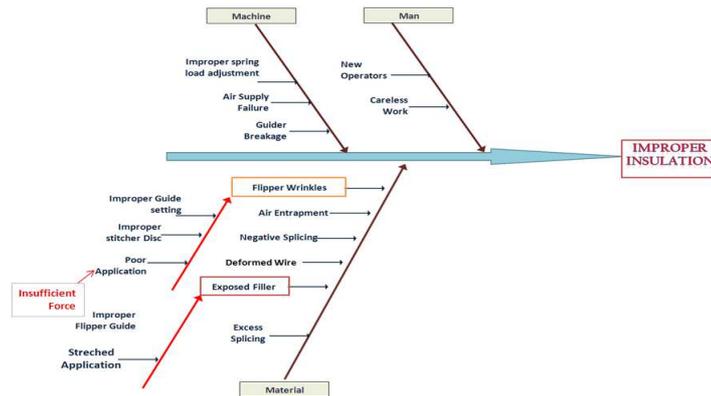
**Figure 6: Final Cause and Effect Diagram for the Improper Insulation Flipped Bead**

Reasons for the improper insulation was identified as poor application and the root cause of poor application is due to insufficient force acting on the flipper guide mechanism.

From the cause and effect diagram, the root cause of flipped bead shortage was identified. In the case of improper insulation of flipped bead is identified as the major cause of flipped bead shortage. Insufficient force acting on the flipper guide is the root cause for the improper insulation. By providing the DSBC 32-125 mm cylinder having an air pressure of 6 bars and 450N force is the counter measure for preventing the improper insulation of flipped bead.
