## ON THE EFFECTS OF GEOLOGICAL AND HYDROMETEOROLOGICAL FACTORS ON FAILURES AND DISTRESSES OF EARTH DAMS IN NORTH EASTERN NIGERIA

### ABSTRACT

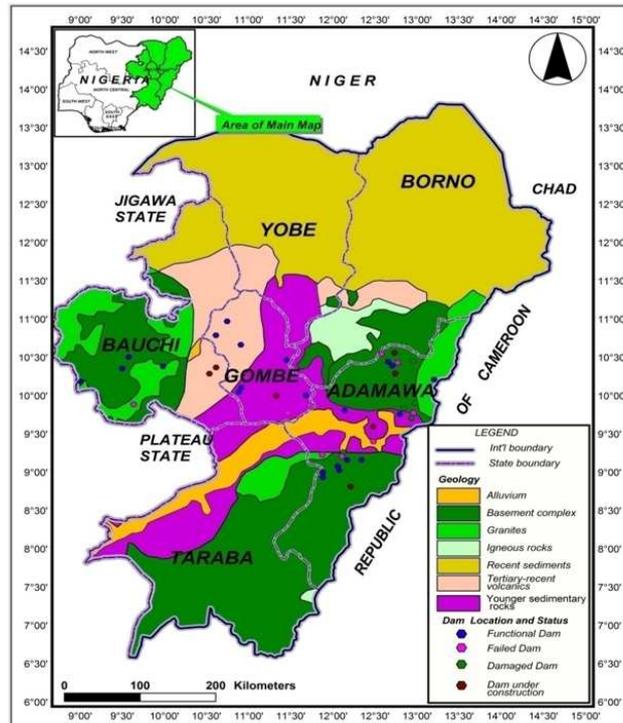
In Figure 1 is presented the geological map of the study area as well as dam locations and status

The geology of the study area is composed of Basement complex, Alluvium, Tertiary to recent Volcanics, Bima and Gombe Sandstones, Yolde, Pindiga, Gombe and Kerri-kerri formations, Igneous rocks, Recent sediments, Younger sedimentary rocks and Younger granites. The GPS indicated that the dams in the study area are located on all these geological formations. Each of these geological formations poses the question of stability, water tightness and sound foundation for dams and reservoirs in the study area. Of the dams sited on the Basement complex, 61, 27 and 11% were functional, failed and distressed respectively.
