## VIBRATION ANALYSIS OF CRITICAL MOTOR

### PROBLEM DEFINITION

The CP1B motor has generated severe noise. When it had checked, the abnormal vibration has shown in the spectrum which led to decline of its performance. There are various reasons which cause of decline of its performance. This study is focus on how to reduce the severe noise that affects the performance of the motor.

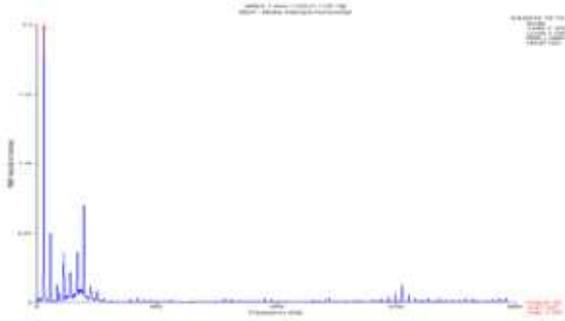
Figure 7: Vibration Spectrum Showing Velocity

In the motor (inboard horizontal) spectrum the rms velocity is about 2.26mm/s and the peak to peak value is about +2.5 to -2.25. Both values are below 2.3mm/s and 10 respectively. In that we can infer that it is up to the performance.

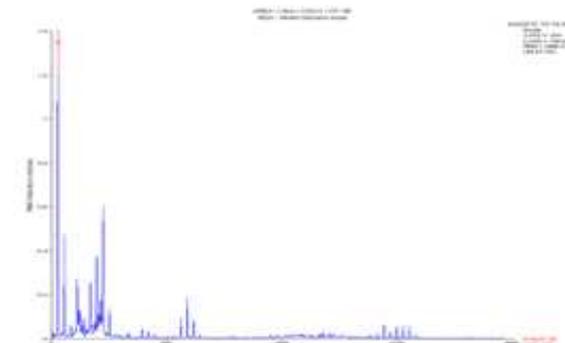
Figure 11: Vibration Spectrum Showing Velocity

In the motor (inboard axial) spectrum the rms velocity is about 1.345 mm/s and the peak to peak value is about +1.21 to -1.47. The rms velocity has reduced and the peak to peak value also has reduced. So we can infer that it is up to the performance.
