RELIABILITY IMPROVEMENT OF PLANT ASSETS THROUGH CONDITION BASED MAINTENANCE: A CASE STUDY

RINTU GEORGE THOMAS¹, DEVIPRASAD VARMA², BRIJESH PAUL³ & CIBU K VARGHESE⁴

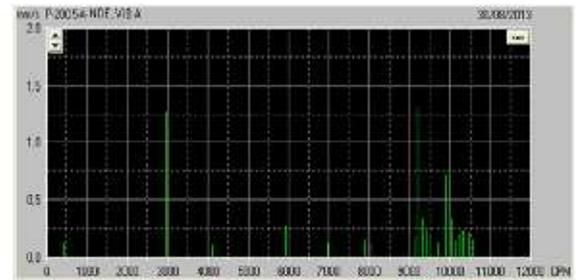
Figure 12: Frequency Spectrum PNDE Axial Direction

severe Bearing damage. Other reasons for high frequency vibrations may be Cavitation, Flow turbulence or recirculation of flowing fluid. For conformation it needs further analysis. In PNDE, the horizontal velocity readings (4.51 mm/sec) are in ALARM limit and vibration frequency of 3* rpm is dominant, which also indicates misalignment. In MDE and MNDE, high amplitudes at axial direction in 1* rpm is dominant, which also indicates severe misalignment.

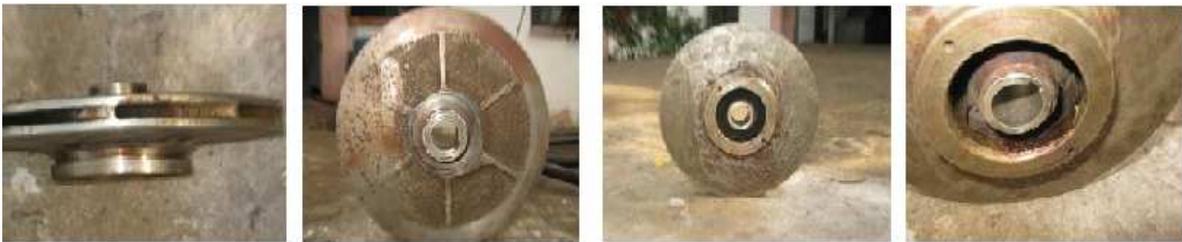
By an effective monitoring and expert discussion, the causes like improper mounting, improper lubrication and indirect failures were avoided and the only cause left is impeller unbalance. So the pump was isolated and decoupled from the motor at the site and then it was shifted to maintenance workshop for overhauling. On dismantling the pump, it was observed some severe material removal in the pump's impeller surface. The shape of the cavities generated implies an erosive effect occurred due to Cavitation and so it is finalized as the root cause of the pump failure.

The collapsing bubbles make a distinctive noise, which has been described as a growling sound leads to severe vibration and resulted in impeller damage. The photograph of damaged impeller due to cavitation erosion is shown in Figure 18.

Figure 23: Impeller Damage Due to Cavitation Erosion

The solution to pump impeller Cavitation lies in finding a material that can withstand high pressures, bear harsh environments, and be machinable. At present, no readily available alloy can do that cost effectively. Thus the only tangible way to salvage the pump is to protect it with a sacrificial material that is readily available, easy to use, and cost-effective. Technological advances in industrial protective coatings and repair composite materials have made it possible to repair pumps suffering from Cavitation, rather than simply replacing them. Cavitation-Resistant (CR) Elastomers can retain adhesion under long-term immersion, dissipate energy created under high-intensity Cavitation, and provide outstanding resistance to corrosion and other forms of erosion.
